# Damage Study in an AA 2024 T3 Panel Subjected to Explosive Loading

by T. Sano, C. Fountzoulas, C. F. Yen, C. Chen, and M. Nansteel

ARL-RP-369 May 2012

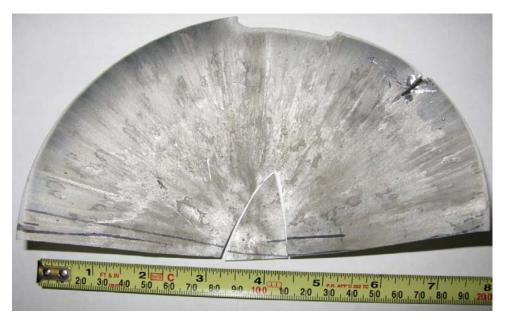
Figure 2. Triangular sample examined from the not-ruptured panel, in relation to the blast area
